Case Studies in Construction Materials

Ankara Temple (Monumentum Ancyranum/Temple of Augustus and Rome) restoration

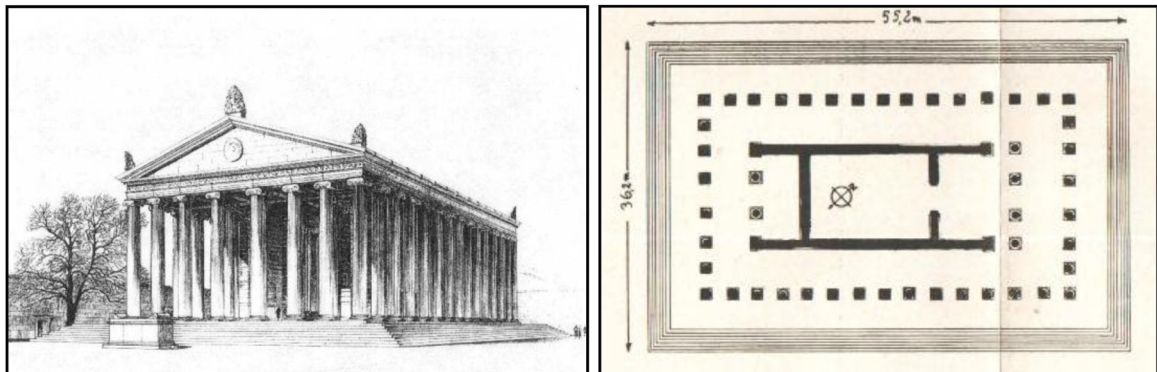
Fig. 2. The Temple in Ankara (Der Tempel in Ankara), (Schede, 1936).

A solution for roofing, which is compatible with the roofing system in the original building (Fig. 2), can preserve the structure against climatic parameters and it can provide sustainability for the static equilibrium of the building. Such a precaution has to be taken urgently.

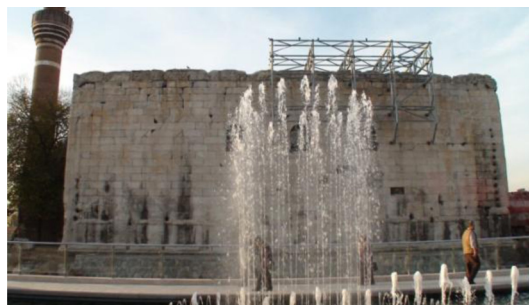
Fig. 6. Pool with fountain.

The pool with fountain (Fig. 6), on the south side of the historical temple, is increasing the moisture rate and it is accelerating the deterioration of the Greek manuscript on the south sidewall of the temple. The original copy of the manuscript was in Rome and it was destroyed centuries ago. Therefore it is very important to keep the only remaining copy. The information given in the manuscript do not only belong to Roman Emperor Augustus, but also include important information about Roman history. Therefore, rather than a fountain, a classical hydrophore (pressurized recirculation pump) where the water is pouring step by step can be used. A pool system where the water is recirculating by machines can be considered.

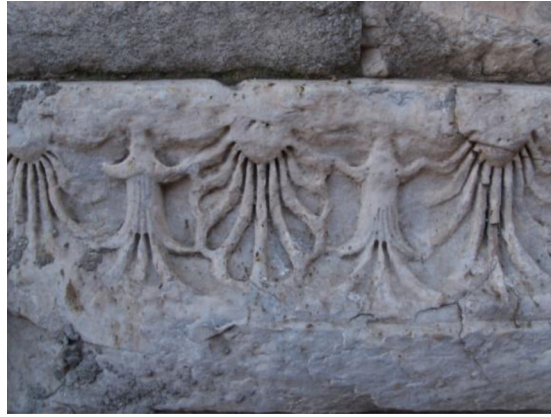
Fig. 7. Deteriorations (external walls).

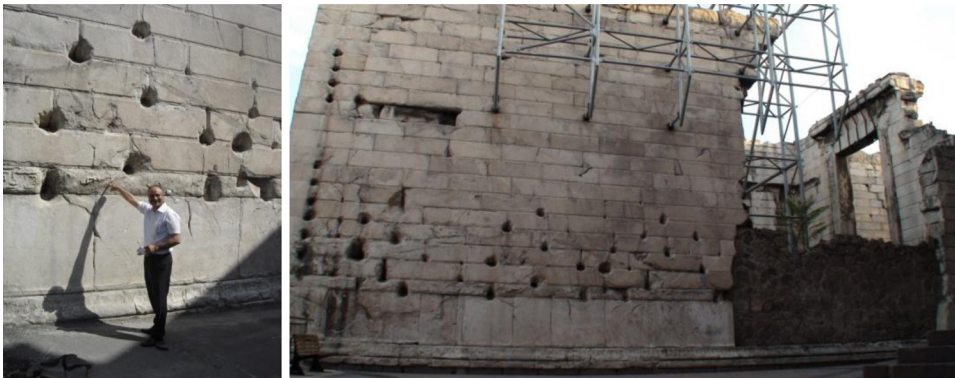
Fig. 9. Deteriorations and Wrecks on the northern side walls.

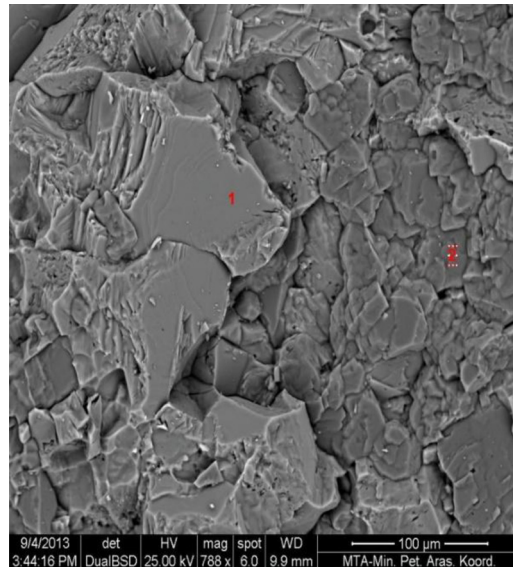
Fig. 11. SEM analysis (1, 2) photograph.

In the regions which include that structure, the particles are mostly arranged homogeneously, the shapes of them are cornered and fractured and the dimensions are in micrometers. The distances between these particles are seen to be narrowed. The dimensions are around 0.35–0.91 μm . In addition, spherical and closed spacing particles are seen along with geometrical shaped particles.

Another property which is seen in the SEM photographs is that the particles, which have different sizes and shapes, have similar color tones. Although some particles are dark gray in color, in some regions light gray and white particles are also seen. This situation is obvious in all successive analysis. The image which is seen in the SEM photographs is a typical cytsalline structural shape which is also defined in the literature. A homogenous structure is observed, the particles are observed to be in a tight form, large cavities and large particles are not observed.

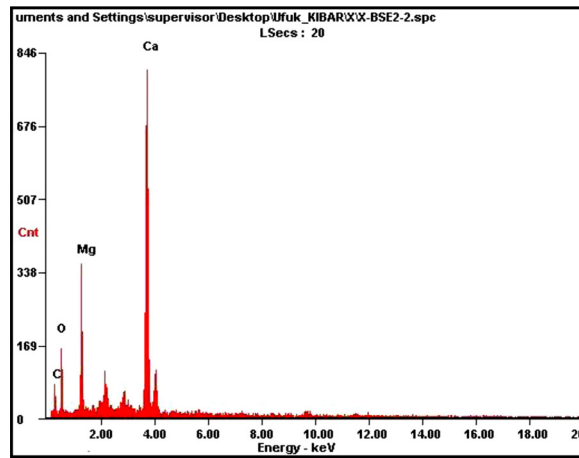
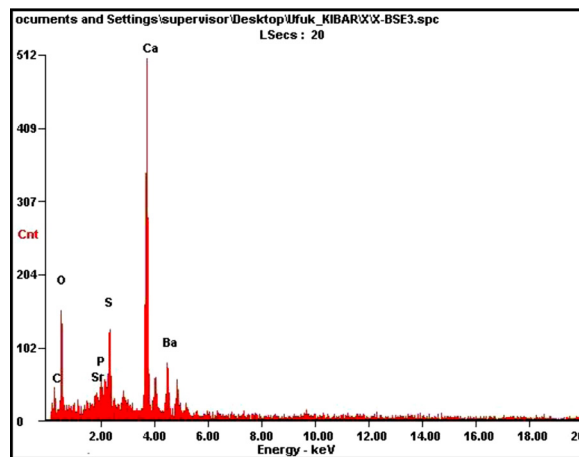
Fig. 12. EDS analysis graphic.

Fig. 13. EDS analysis graphic.

EDS analysis was applied by focusing on a point of 2 μm and it is applied by searching an area of (50 $\mu\text{m} \times 50 \mu\text{m}$). This procedure is applied in a depth of 2.5 μm . In this analysis, the pure structure of the experiment sample is observed. In Tables 3 and 4, atomic percentages which were obtained from EDS analysis are given.

Moreover, EDS analysis indicate that various dissolutions were not formed, thus mainly a pure structure is observed during the analysis.

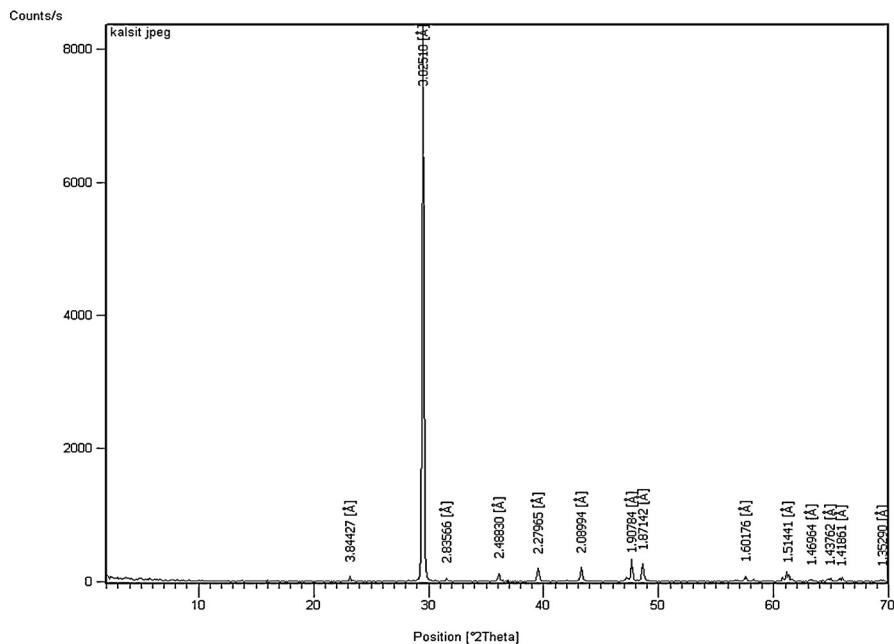
Fig. 14. XRD analysis graphic.

According to the results of XRD analysis in Fig. 14, the exterior and interior of main body of Naos are composed of calcite mineral.

While defining the microstructure of the experiment sample and while examining the crystal structure, X-ray analysis provided important findings. In the process, applying sintering with heat, the experiment samples are monitored from the nucleation phase to the last crystallization phase for crystallization duration and structural changes with XRD. These analysis have lots of benefits for observing different crystalline structures and for defining the appropriate heating conditions as well. Because of the same reason, the similarity between peak points indicates that the structure, which constitutes the sample, is in a pure phase, meaning that it is mainly composed of calcite mineral.

Turkish Republic Ministry of Energy and Natural Resources, MTA Mineralogy and Petrography Analysis Laboratory Unit has made Scanning Electron Microscope (SEM) and EDS (Figs. 11–13), and X-ray diffraction (XRD) analysis (Fig. 14). With respect to the analysis, the main component of the temple is determined to be stone with calcite mineral. According to this determination, the materials and chemicals which will be used in the restoration process, have to have calcite mineral origins or they have to be compatible with calcite mineral.
